# WOOLSEY AND HILL FIRES

Watershed Emergency Response Team

Final Report

CA-VNC-091023 and CA-VNC-090993

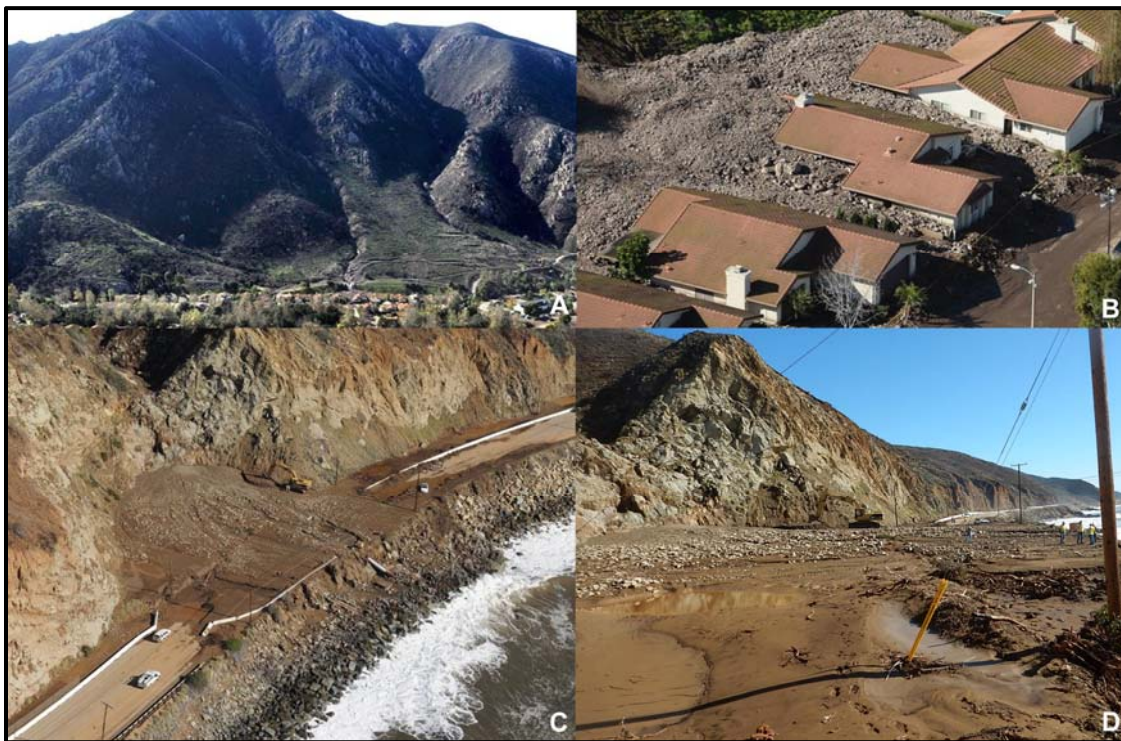
**Figure 14a-d:** (a) Steeply sloping catchments on the northern margin of Conejo Peak showing channels eroded by debris flow movement on 12/12/2014; (b) Homes inundated by debris flows, with boulder fields up to the eaves of the buildings. Primarily cobble- to boulder- size clasts are visible due to dewatering-related evacuation of fine-grained debris flow matrix; (c) Debris flow deposition on the Pacific Coast Highway at Mile Post 3.5 surges pushed K-rails fastened to the ground with steel K-rail pins into the ocean; (d) Debris flow deposition at Mile Post 3.5, view east.

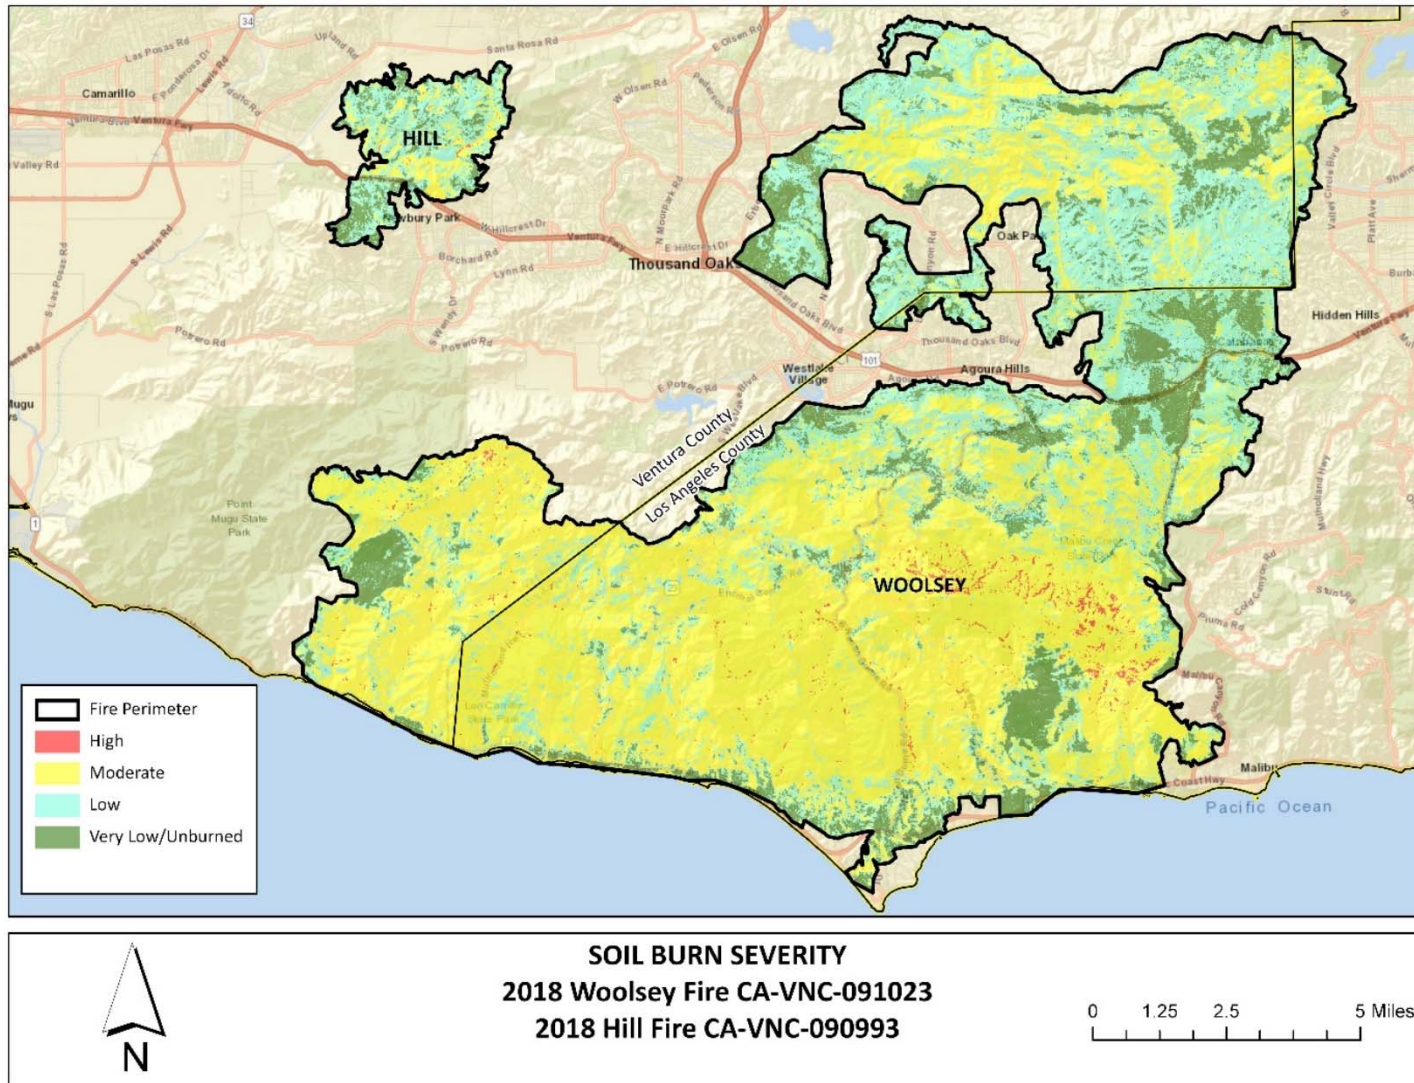
Figure 19 is a map of SBS for both fires and shows the spatial pattern of SBS throughout the burn area. The map shows that the Woolsey Fire burn area is dominated by moderate SBS, while the Hill Fire is dominated by low SBS. Minor areas of high SBS for the Woolsey Fire are most common on the north facing slope near Castro Peak, along the Backbone Trail (crest of the Santa Monica Mountains).

**Figure 19.** The soil burn severity map for the Woolsey and Hill fires.

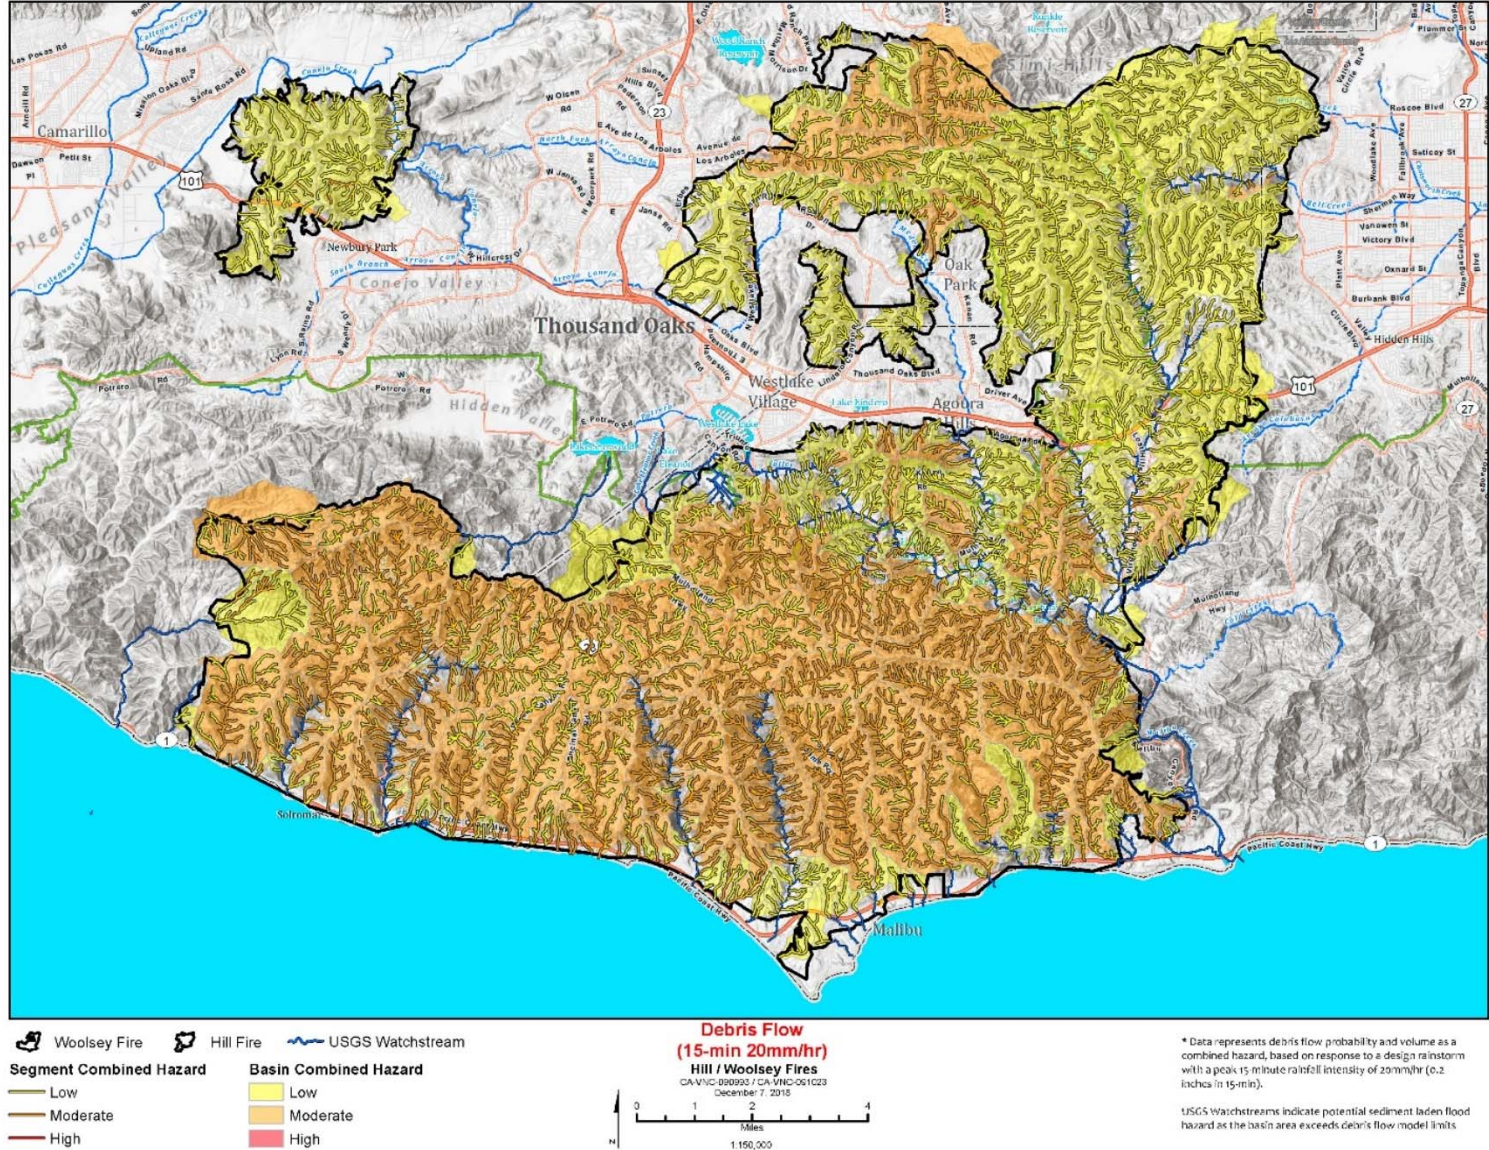
- The National Weather Service flash flood warning/watch threshold of 0.2 inches in 15-minutes (i.e., 0.8 in hr<sup>-1</sup> or 20 mm hr<sup>-1</sup> for the 15-minute duration) equates to a moderate combined hazard for the majority of the Woolsey Fire, and a low combined hazard for the majority of the Hill Fire (see Figure 20).

**Figure 20.** Combined debris flow hazard for the Woolsey and Hill fires for a 20 mm hr<sup>-1</sup> 15-minute storm event. This event equates to a precipitation depth of approximately 0.2 inches in 15 minutes.

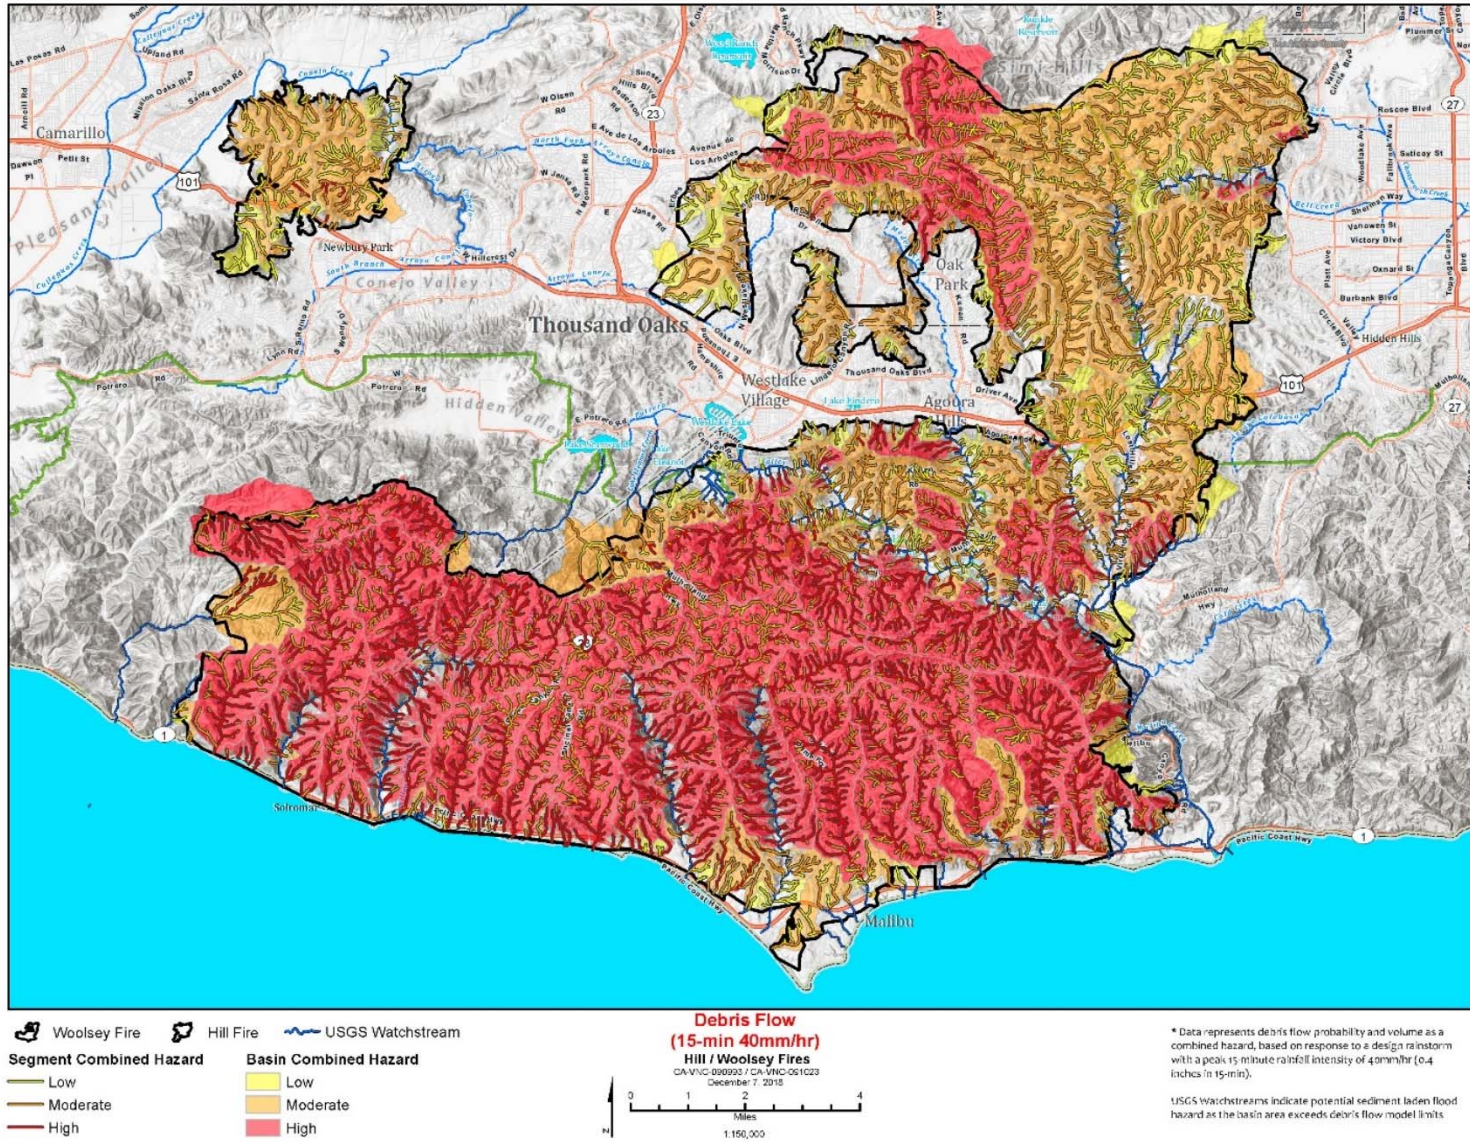
- A storm scenario of approximately 0.4 inches in 15-minutes (i.e., 1.6 in hr<sup>-1</sup> or 40 mm hr<sup>-1</sup>) equates to a high combined hazard for the majority of the Woolsey Fire, and a moderate combined hazard for the majority of the Hill Fire (see Figure 21). This storm scenario is highly probable within the next two years following the fire.

**Figure 21.** Combined debris flow hazard for the Woolsey and Hill fires for a 40 mm hr<sup>-1</sup> storm event. This event equates to a precipitation depth of approximately 0.4 inches in 15 minutes.

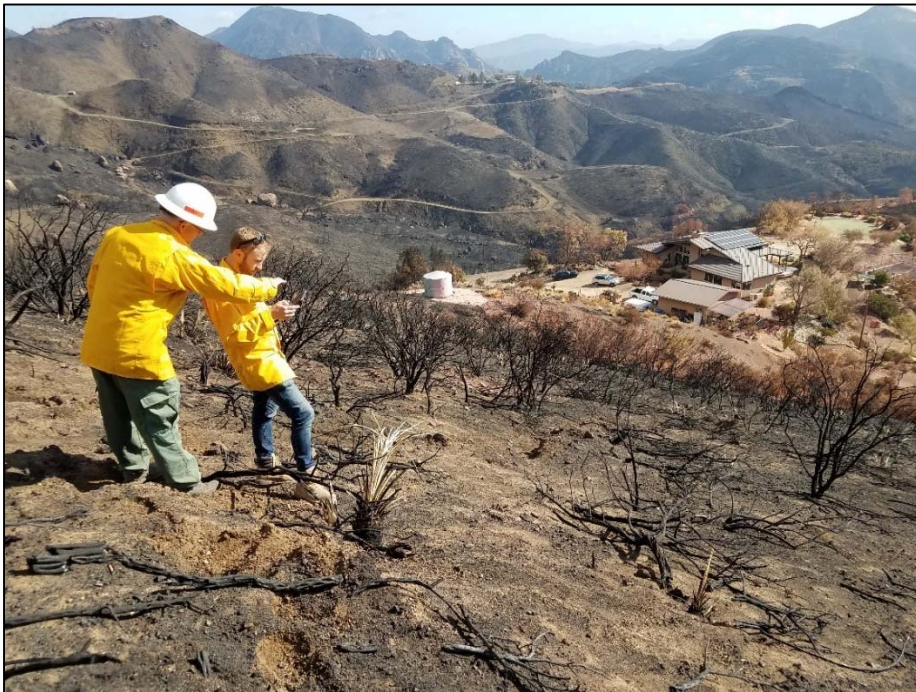
E-2. WERT VAR identification in the Little Sycamore Canyon, located in the Santa Monica Coastal Front region.

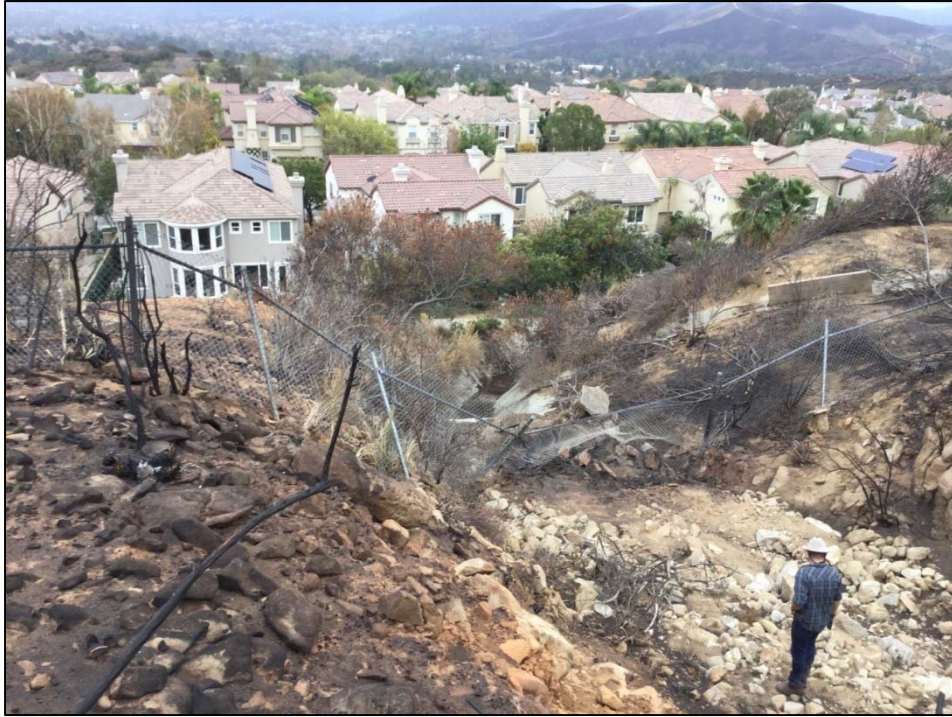
E-3. Oak Park existing hazard recorded by the WERT (Malibu Creek north region)

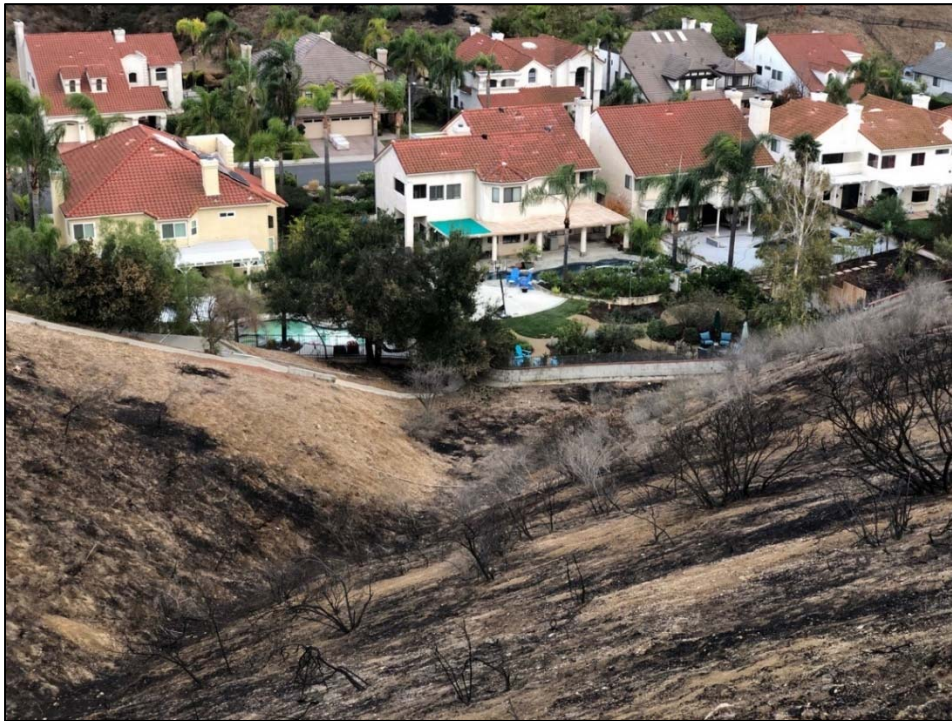
E-4. Oak Park homes determined to be at risk from flooding and debris flows.

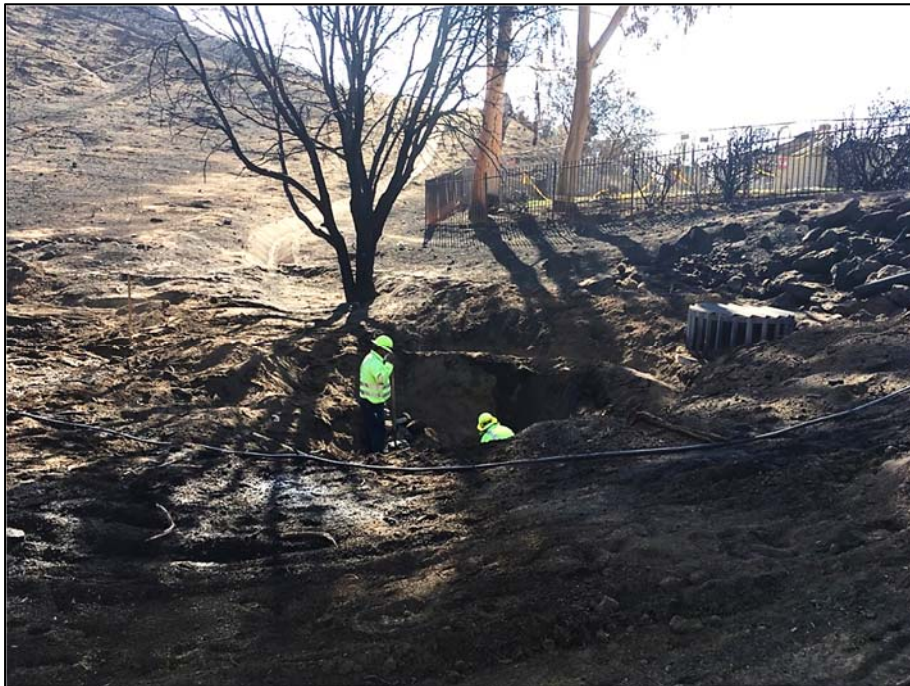
E-12. Wembly Avenue debris basin filled with sediment, Oak Park.
