# WOOLSEY AND HILL FIRES

Watershed Emergency Response Team

Final Report

CA-VNC-091023 and CA-VNC-090993

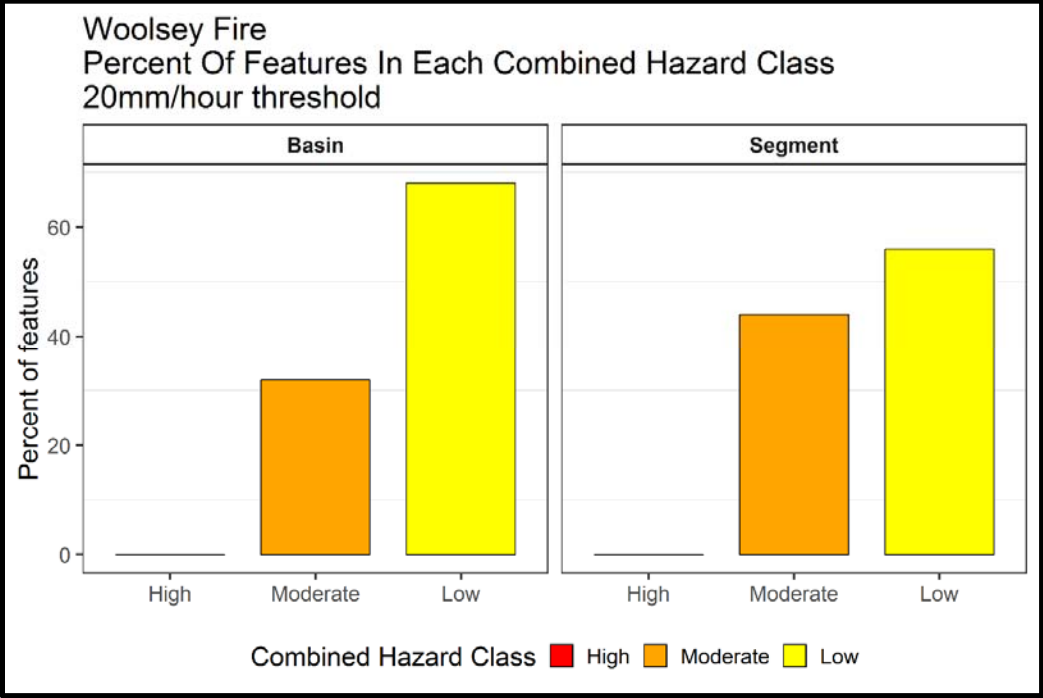
Figure 22 and Figure 23 show the percentage of 15-minute basins and stream segments classified by combined debris flow hazard for the 20 mm hr<sup>-1</sup> design storm (i.e., approximately 0.2 inches in 15 minutes) and 40 mm hr<sup>-1</sup> design storm (i.e., approximately 0.4 inches in 15 minutes), respectively. Under the 15-min 20 mm hr<sup>-1</sup> storm scenario, approximately 68 and 32 percent of basins are classified as having a low and moderate combined hazard, respectively, with none classified as having high combined hazard. Under the 15-min 40 mm hr<sup>-1</sup> storm scenario, only 21 percent of basins are modeled as having low combined hazard, whereas 45 and 34 percent are modeled as having moderate and high combined hazard, respectively. Additional debris flow model outputs for the Woolsey Fire are displayed in Appendix B.

**Figure 22.** Percent of basins and stream segments in the Woolsey Fire by combined debris flow hazard class for the 15-minute 20 mm hr<sup>-1</sup> storm. This event equates to a precipitation depth of approximately 0.2 inches in 15 minutes.

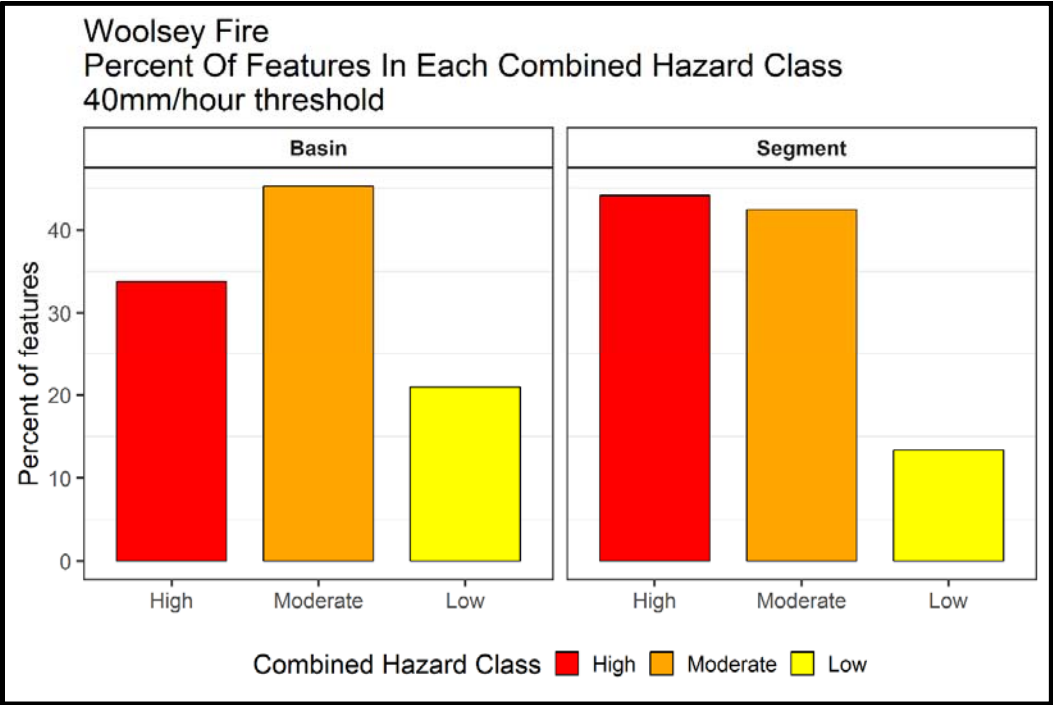
**Figure 23.** Percent of basins and stream segments in the Woolsey Fire by combined debris flow hazard class for the 15-minute 40 mm hr<sup>-1</sup> storm. This design storm equates to a precipitation depth of approximately 0.4 inches in 15 minutes.

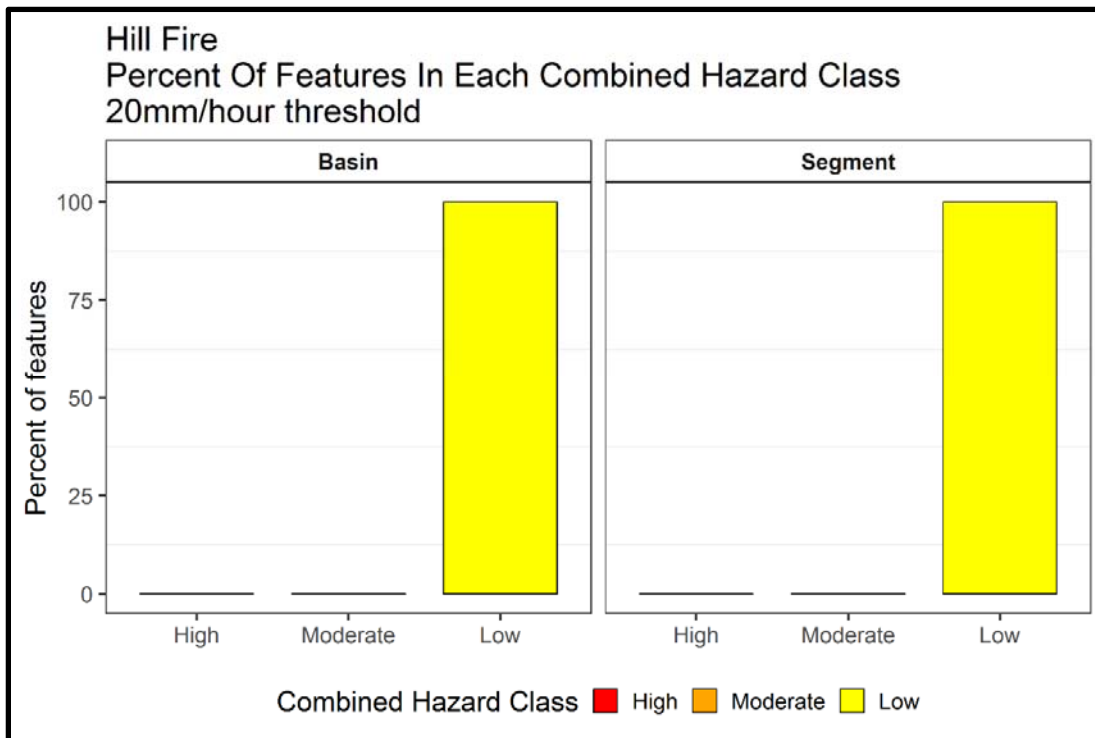
Figure 24 and Figure 25 show the percentage of 15-min basins and stream segments classified by combined debris flow hazard for the 20 mm hr<sup>-1</sup> design storm (i.e., approximately 0.2 inches in 15 minutes) and the 15-min 40 mm hr<sup>-1</sup> design storm (i.e., approximately 0.4 inches in 15 minutes, respectively). Under the 15-min 20 mm hr<sup>-1</sup> storm scenario, 100 percent of basins are classified as having a low combined hazard. Under the 15-min 40 mm hr<sup>-1</sup> storm scenario, 56 percent of basins are modeled as having low combined hazard, whereas 44 percent are modeled as having a moderate combined hazard.

**Figure 24.** Percent of basins and stream segments by combined debris flow hazard class for the Hill Fire for the 15-minute 20 mm hr<sup>-1</sup> storm. This design storm equates to a precipitation depth of approximately 0.2 inches in 15 minutes.

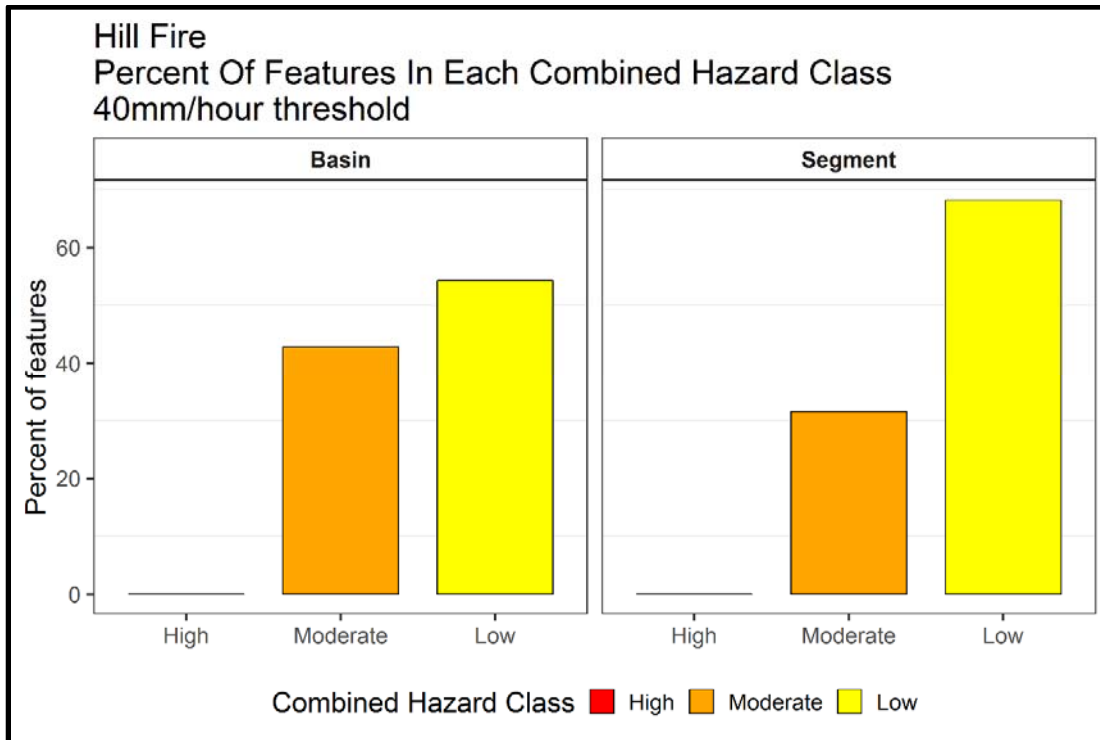
**Figure 25.** Percent of basins and stream segments in the Hill Fire by combined debris flow hazard class for the 15-minute 40 mm hr<sup>-1</sup> storm. This design storm equates to a precipitation depth of approximately 0.4 inches in 15 minutes.

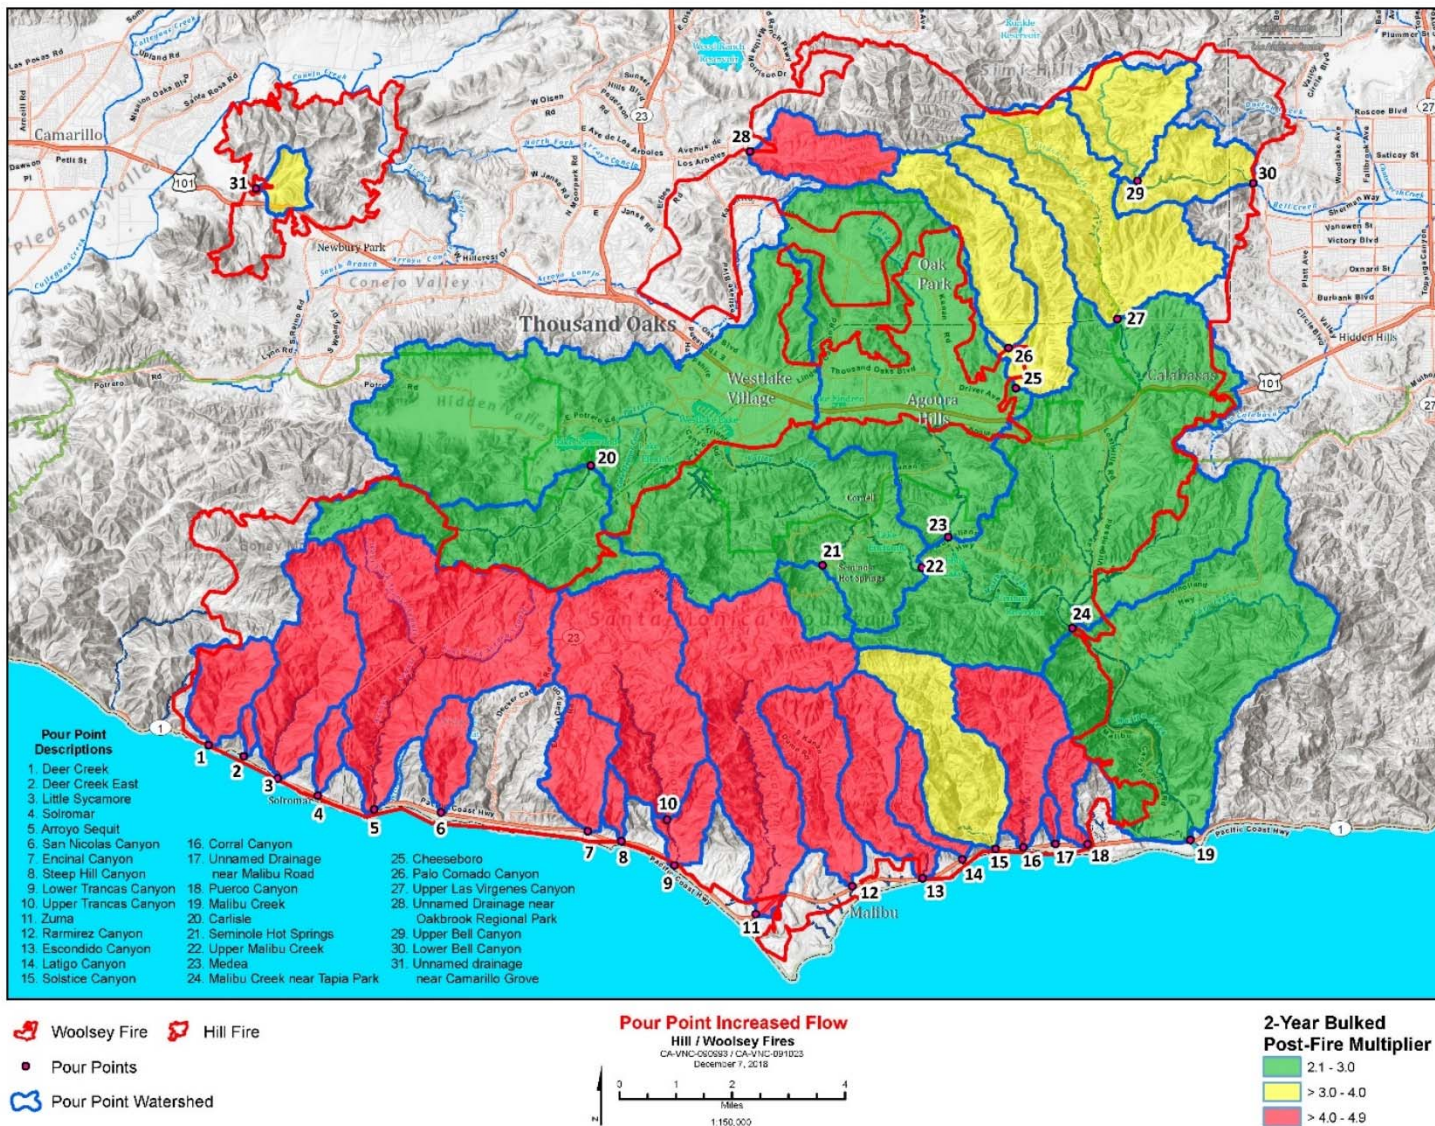
Thirty-one pour point watersheds were established for the Woolsey and Hill fires to estimate potential post-fire peak flow increases to Values-at-Risk from flooding and sediment-laden flood hazard. Figure 26 shows that the pour point locations are concentrated along the Pacific Coast Highway near the Pacific Ocean and widely scattered throughout the remainder of the Woolsey Fire. Only one pour point watershed was selected for the Hill Fire due to its much smaller size and the limited number of drainages that can directly impact VARs. These pour points represent the highest potential for life-safety related flood hazard and/or debris flow impacts to Los Angeles and Ventura county residents. Most of the pour points are located close to the fire perimeter, yielding greater post fire flow increases than those far below the fire perimeter.

most important for this rapid assessment, not the estimated absolute values of the peak flows. Table 7 shows the drainage area of the pour point watersheds, the percentages in each soil burn severity category, and the bulked post-fire multiplier for 2-year and 10-year recurrence interval peak flows. Figure 26 displays the two-year bulked post-fire flow multipliers for the pour point watersheds.

Generation of post-fire flow multipliers for these watersheds indicate a mean 3.9- and 2.9-fold increase for bulked 2-year and 10-year recurrence interval flows, respectively.<sup>8</sup> Individual pour point watersheds with the highest modeling flood flow increases include Solromar, Upper and Lower Trancas, and Puerco Canyon. The flow multipliers for these watersheds are at 4.8 or 4.9 for 2-year recurrence interval events, and 3.5 or 3.6 for a 10-year event. These multipliers are most appropriately applied within the first two years following the fire, or until ground cover within the burn area is well established.

Figure 26. Map of pour point watersheds and the estimated bulked post-fire flow multipliers for the 2-year storm event.

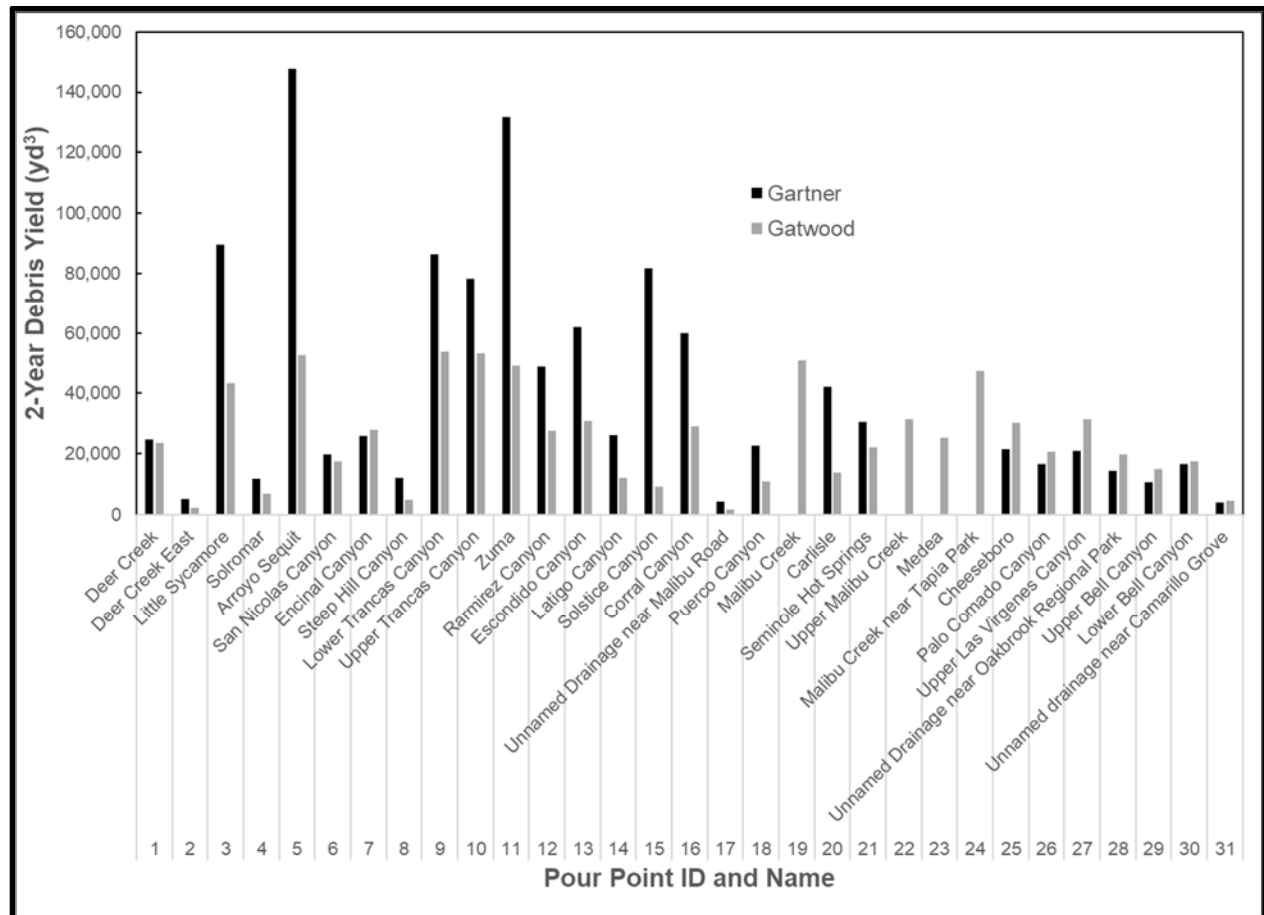
The 2-year storm estimates of debris yield for the 31 pour points suggest that Gartner et al. (2014) generally predicted more debris yield than the Gatwood equations (Gatwood et al. 2000) for watersheds greater than 2.0 mi<sup>2</sup> (Figure 27). The estimates of debris yield were generally more similar between the two methods for the 10-year storm event (Figure 28, Table 8).

The 2-year estimates from Gartner et al. (2014) suggest that watersheds with the largest debris yield are Arroyo Sequit, Zuma Canyon, Little Sycamore Canyon, Trancas Canyon, and Solstice Canyon, respectively. These same watersheds also produce the highest debris yield using Gartner et al. (2000), although not in the same order. The same watersheds also generally produce the highest yields for the 10-year storms. The various pour points along Malibu Creek also produce large absolute debris yields. However, the results for the Malibu Creek watershed are highly uncertain due to the higher degree of urbanization and the presence of water impoundments.

Figure 27. Two-year debris yield estimates for the Woolsey and Hill fire pour point watersheds.

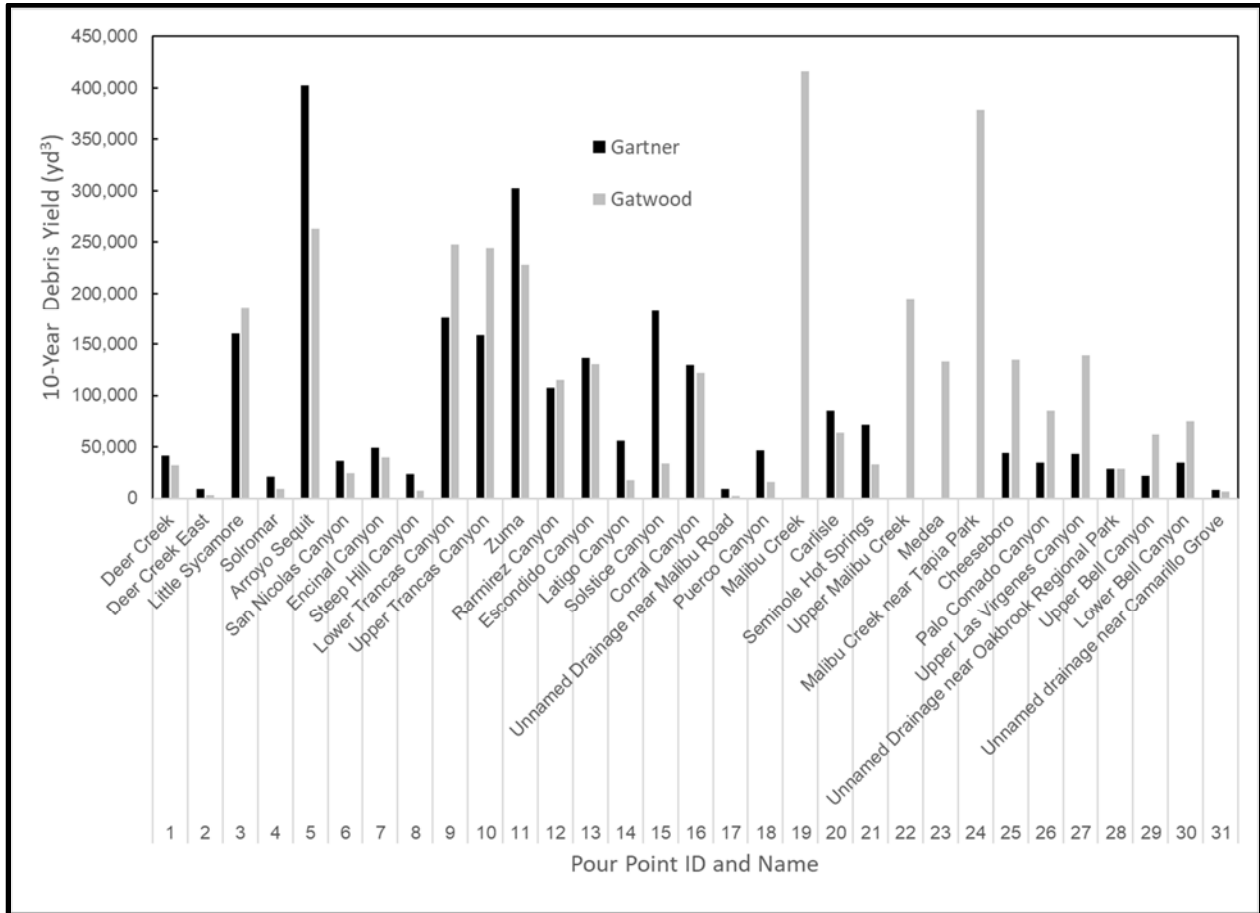
**Figure 28.** Estimated 10-year debris yields for the Woolsey and Hill fire pour point watersheds.

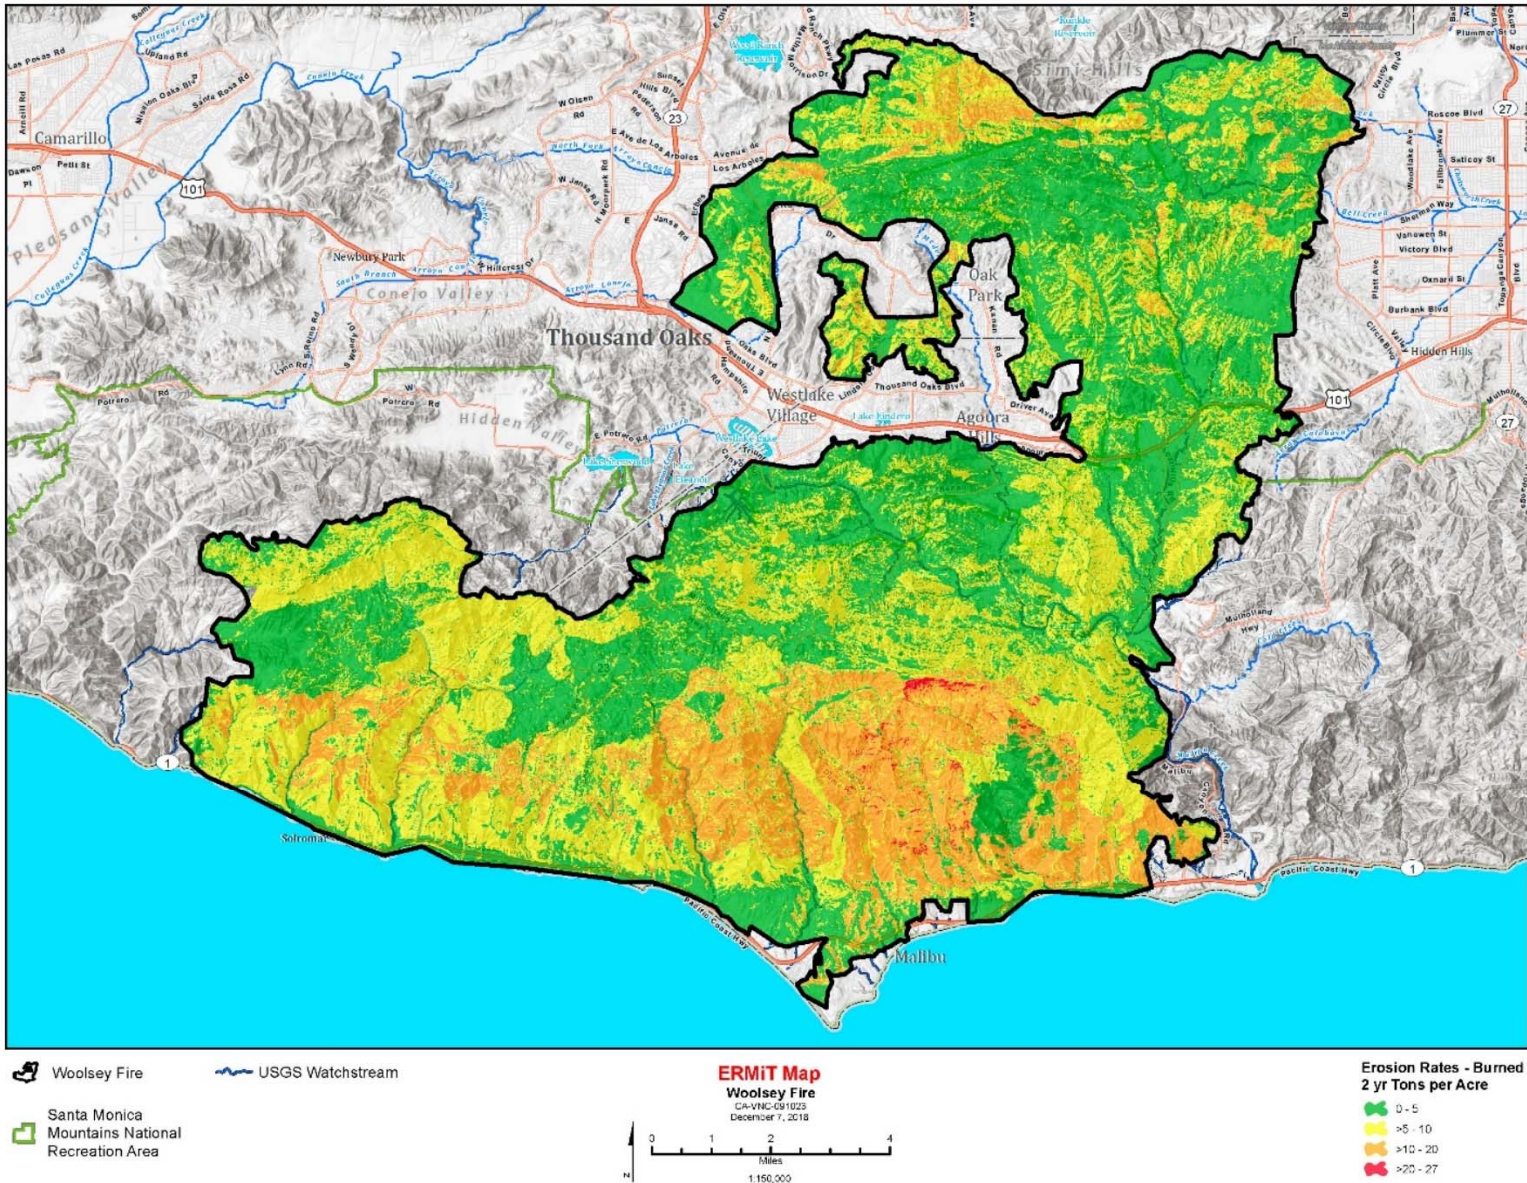
For the Woolsey Fire, ERMiT predicts that surface erosion will increase by 24-fold for the 2-year storm, and a 10-fold increase for the 10-year storm. Figure 29 shows sediment production per unit area for the 50 percent probability storm event for the Woolsey Fire (i.e., 2-year storm). Table 9 summarizes fire-wide sediment production averages for unburned and burned areas for the 2- and 10-year storms for the Woolsey Fire; Table 10 does the same for the Hill Fire. On average, ERMiT predicts that surface erosion for the Hill Fire will increase by 15-fold for the 2-year storm, and a 10-fold increase for the 10-year storm. Figure 30 shows sediment production per unit area for the 50 percent probability storm event for the Hill Fire (i.e., 2-year storm). Empirical data from the 2003 Cedar Fire in San Diego County suggest post-fire erosion rates of approximately 10 to 20 tons acre<sup>-1</sup> yr<sup>-1</sup> for granitic hillslope plots and small catchments in the Peninsular Ranges (Robichaud et al., 2013; Hubbert et al., 2012). This suggests that the 10-year ERMiT run predicts within the range of observed values for the general area.

**Figure 29.** Woolsey Fire predicted range of hillslope sediment production values (tons acre<sup>-1</sup>) for the 2-year storm.

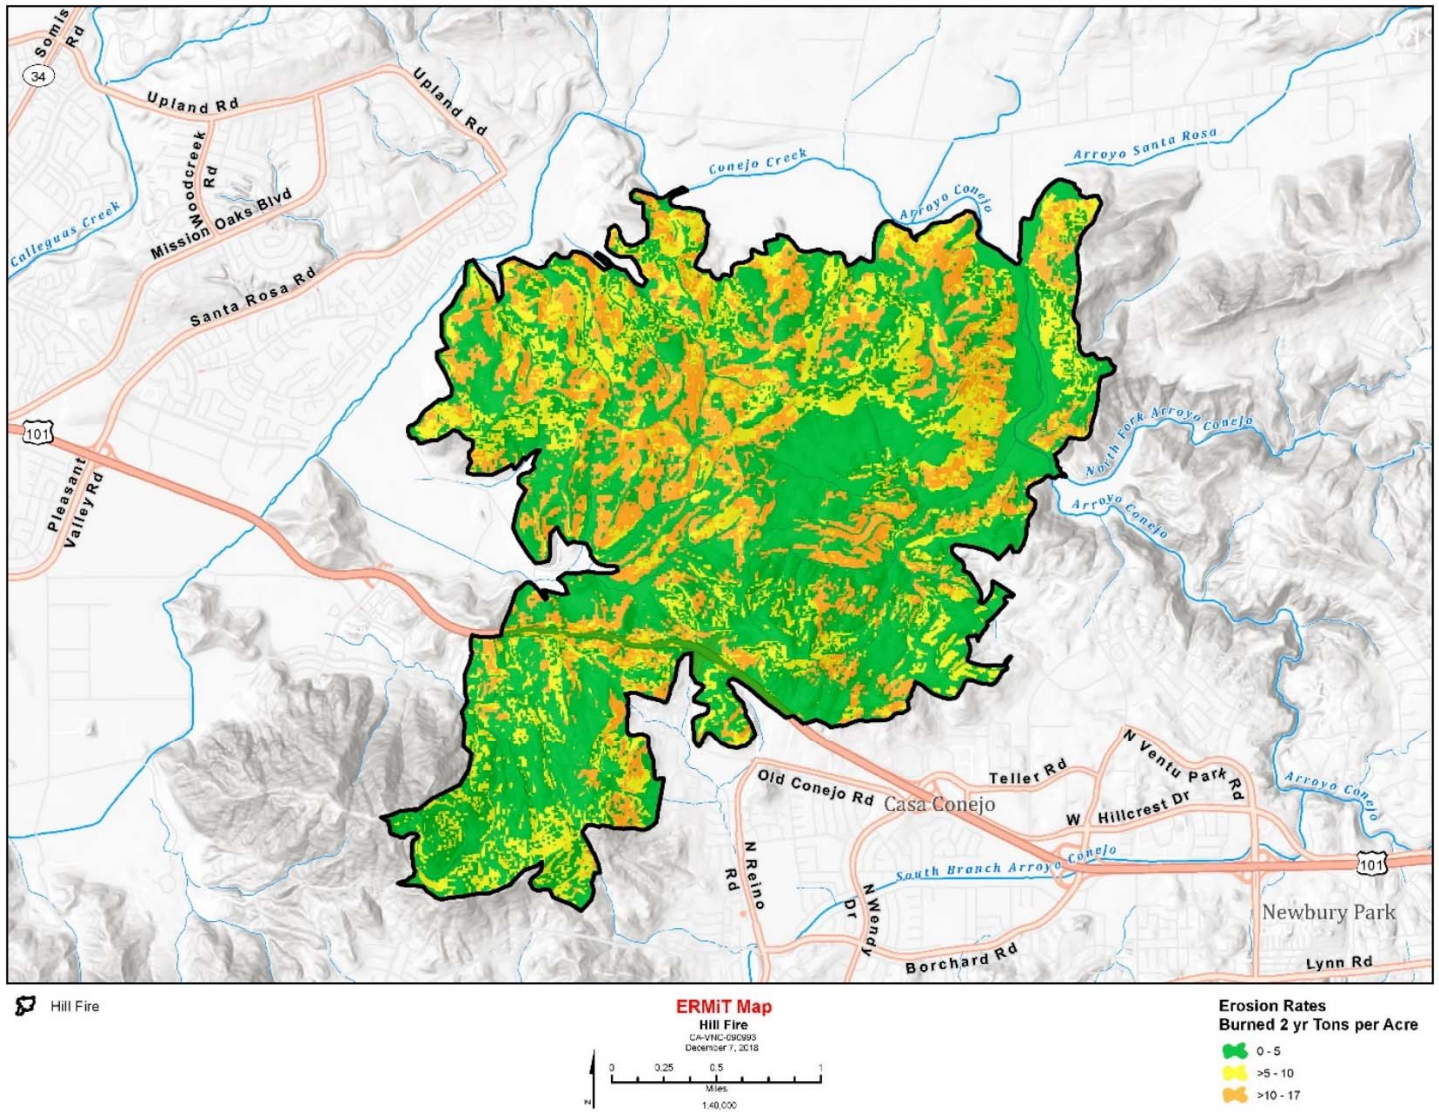
**Figure 30.** Hill Fire predicted range of hillslope sediment production values (tons acre<sup>-1</sup>) for the 2-year storm.

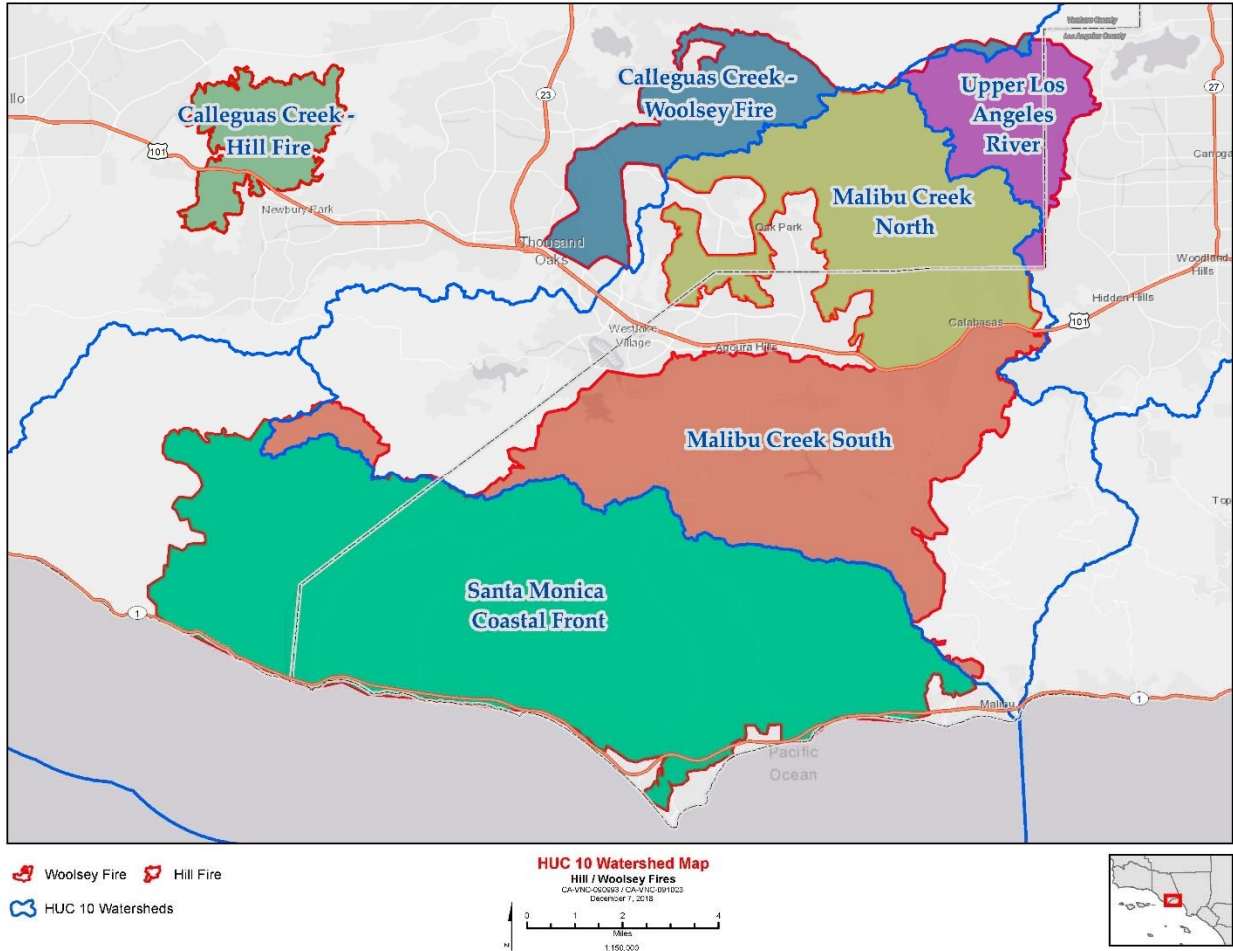
Potential Values-at-Risk (VARs) were grouped into 6 areas defined by HUC 10 watershed boundaries and U.S. Highway 101 (Figure 31). General observations and recommendations for each of these areas are provided below; more detailed observations are provided in the VAR summary table (Appendix C). However, this evaluation is not intended to be comprehensive and/or conclusive, and additional VARs may be identified through more detailed evaluation by responsible agencies. Several limitations include:

**Figure 31.** HUC 10 watershed boundaries and U.S. Highway 101 used to define six areas for more detailed descriptions of Values-at-Risk.

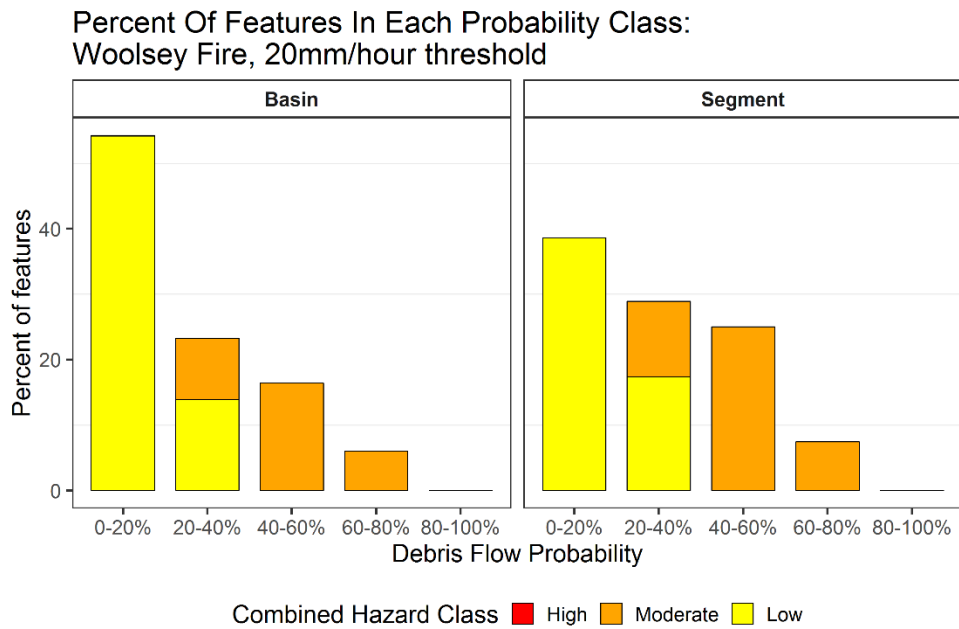
**Figure B-1.** Percent of basins and streams by debris flow probability class for the Woolsey Fire (20 mm hr<sup>-1</sup> for 15-minute duration).

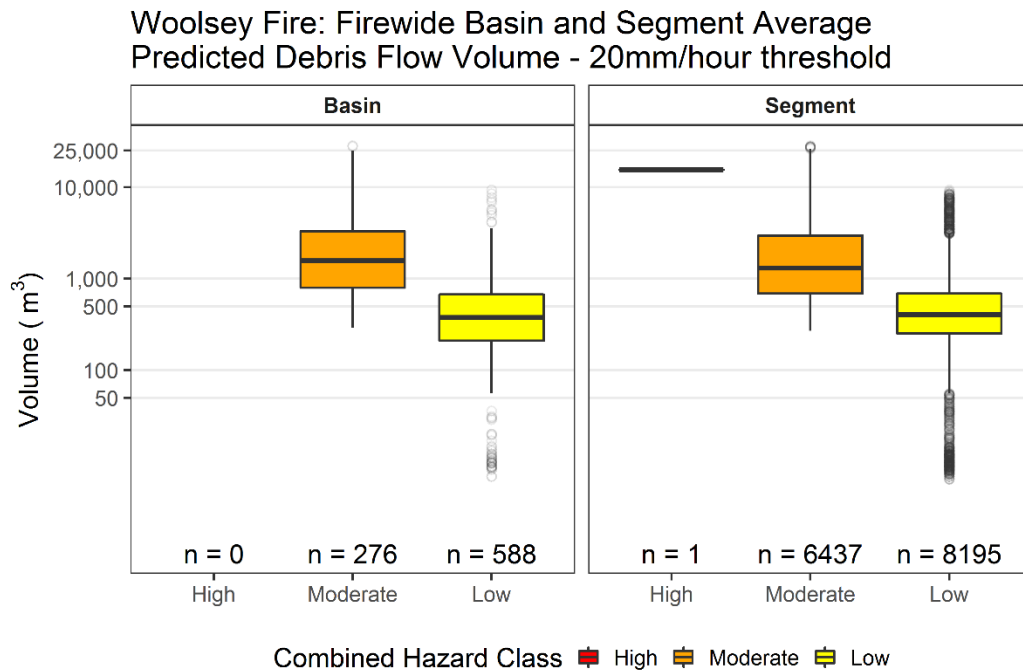
**Figure B-2.** Debris flow volume by basin and stream segment for the Woolsey Fire (20 mm hr<sup>-1</sup> for 15-minute duration).

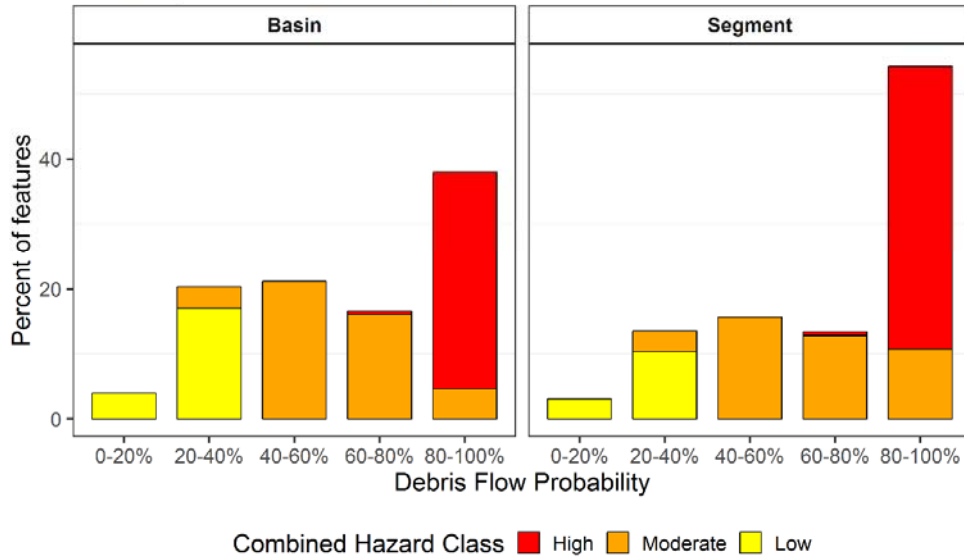
**Figure B-3.** Percent of basins and streams by debris flow probability class for the Woolsey Fire (40 mm hr<sup>-1</sup> for 15-minute duration).

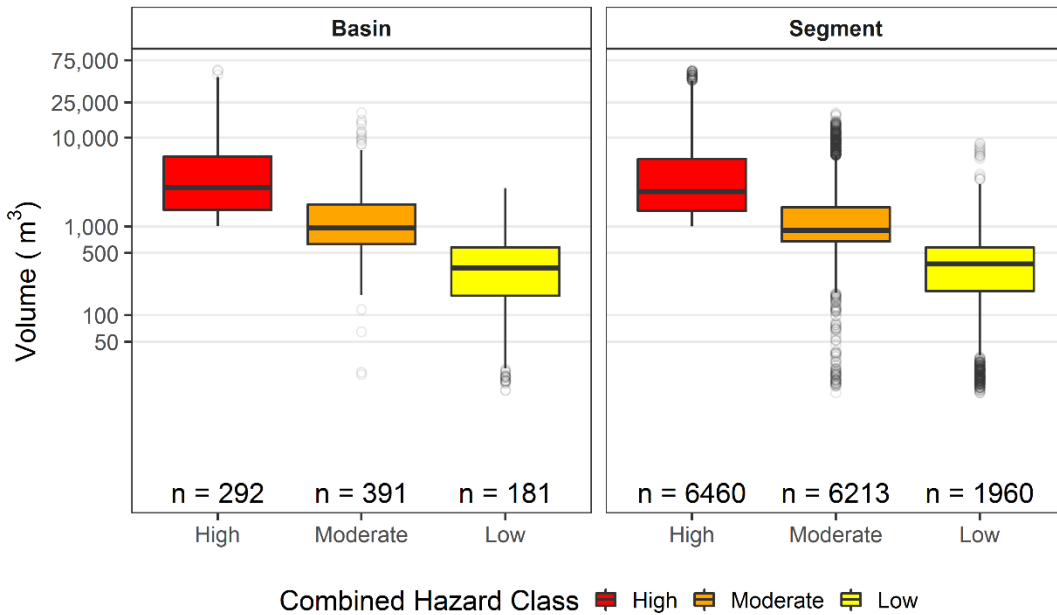
**Figure B-4.** Debris flow volume by basin and stream segment for the Woolsey Fire (40 mm hr<sup>-1</sup> for 15-minute duration).

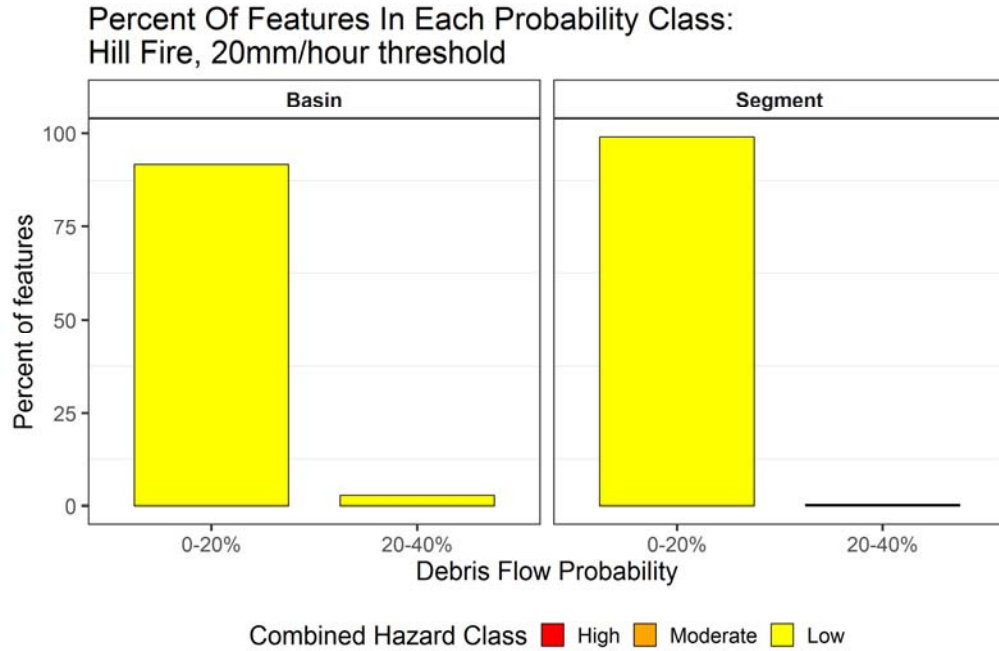
**Figure B-5.** Percent of basins and streams by debris flow probability class for the Hill Fire (20 mm hr<sup>-1</sup> for 15-minute duration).

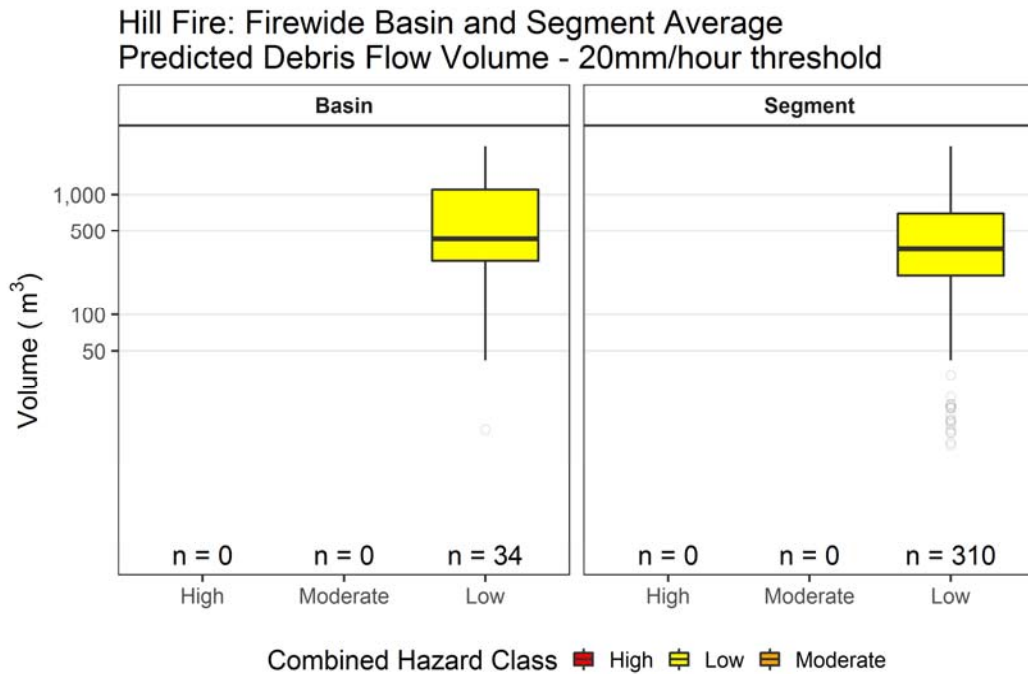
**Figure B-6.** Debris flow volume by basin and stream segment for the Hill Fire (20 mm hr<sup>-1</sup> for 15-minute duration).

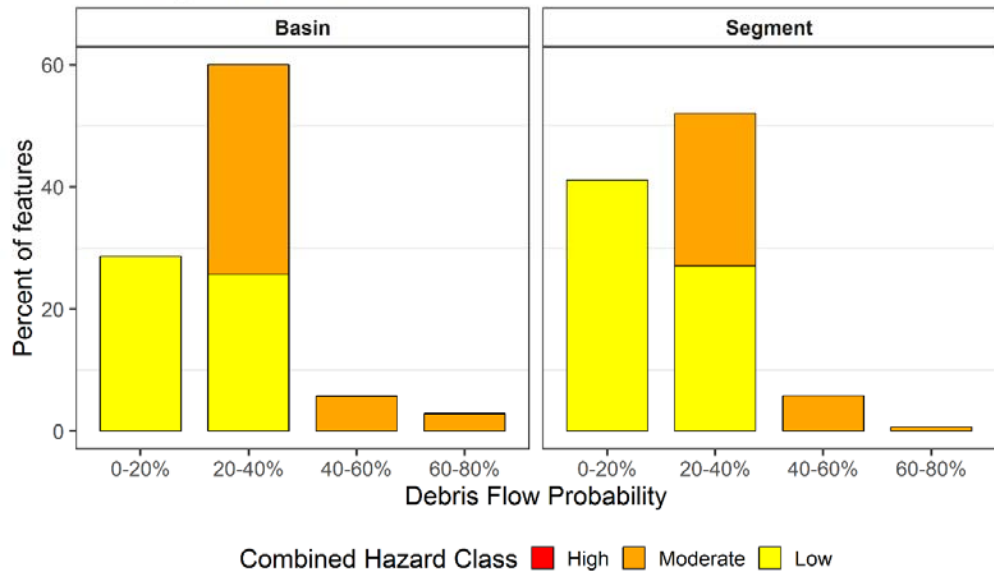
**Figure B-7.** Percent of basins and streams by debris flow probability class for the Hill Fire (40 mm hr<sup>-1</sup> for 15-minute duration).

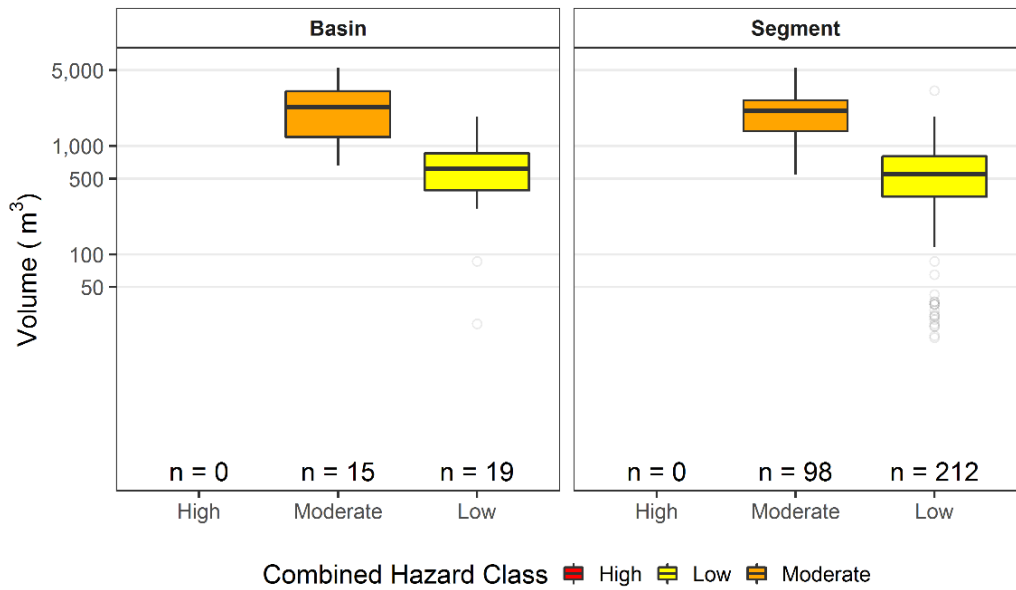
**Figure B-8.** Debris flow volume by basin and stream segment for the Hill Fire (40 mm hr<sup>-1</sup> for 15-minute duration).

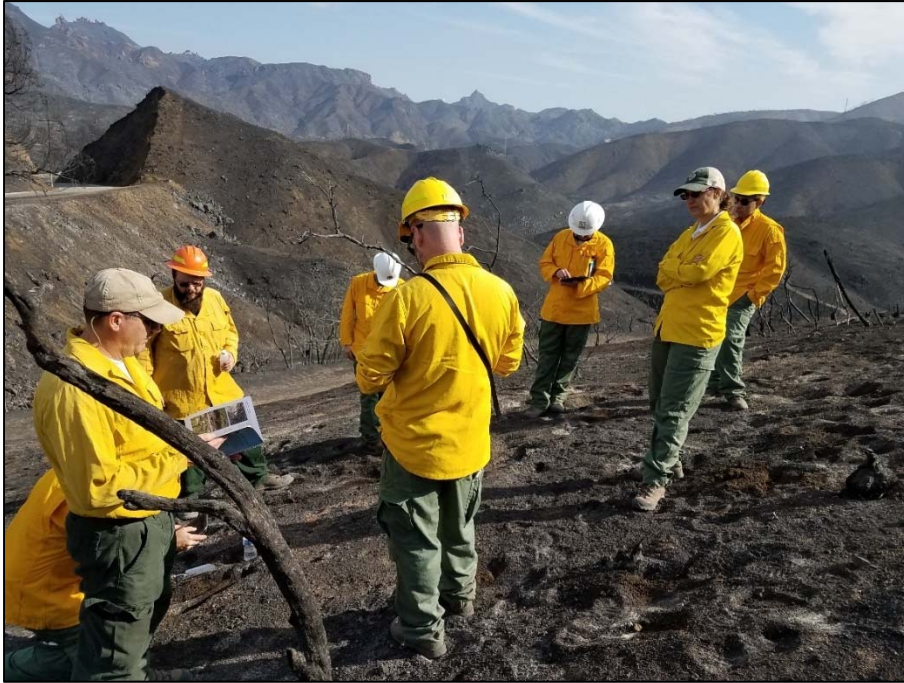
E-1. BARC map validation in the Woolsey Fire with the DOI BAER team on November 21, 2018.

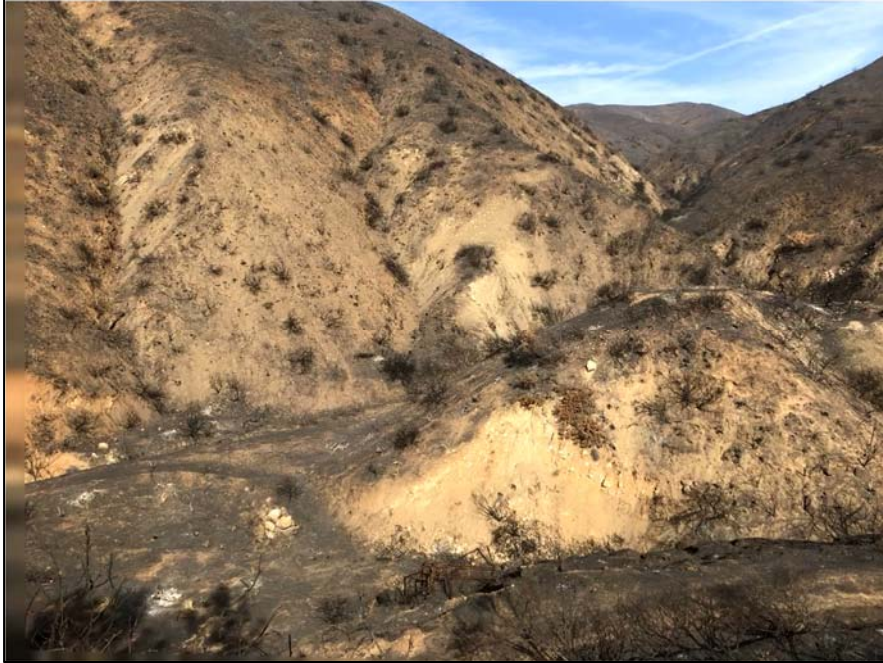
E-5. Dry ravel along Yreba Buena Road, located in the Santa Monica Coastal Front region.

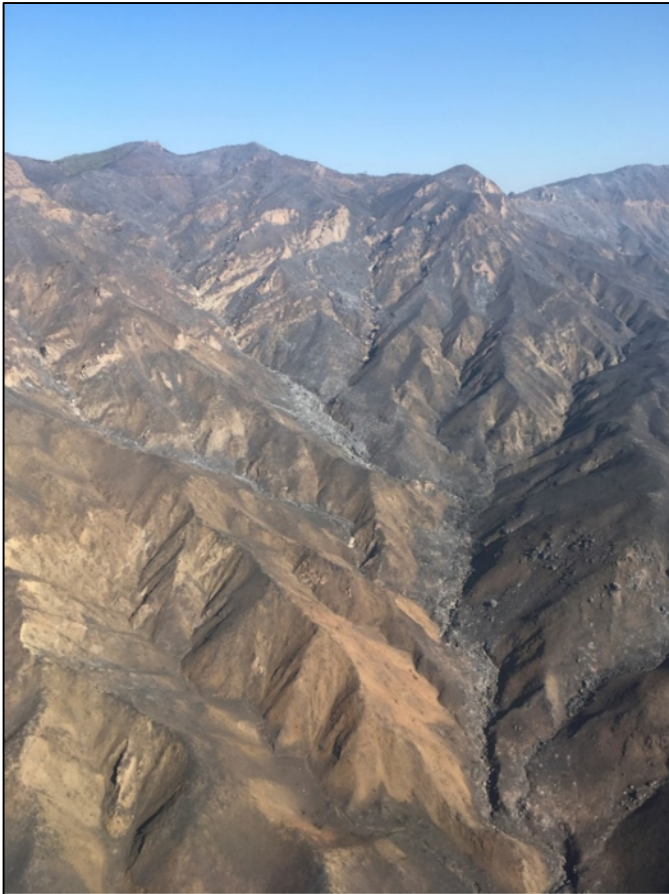
E-6. View of the steep Santa Monica Mountains burned by the Woolsey Fire on November 20, 2018.

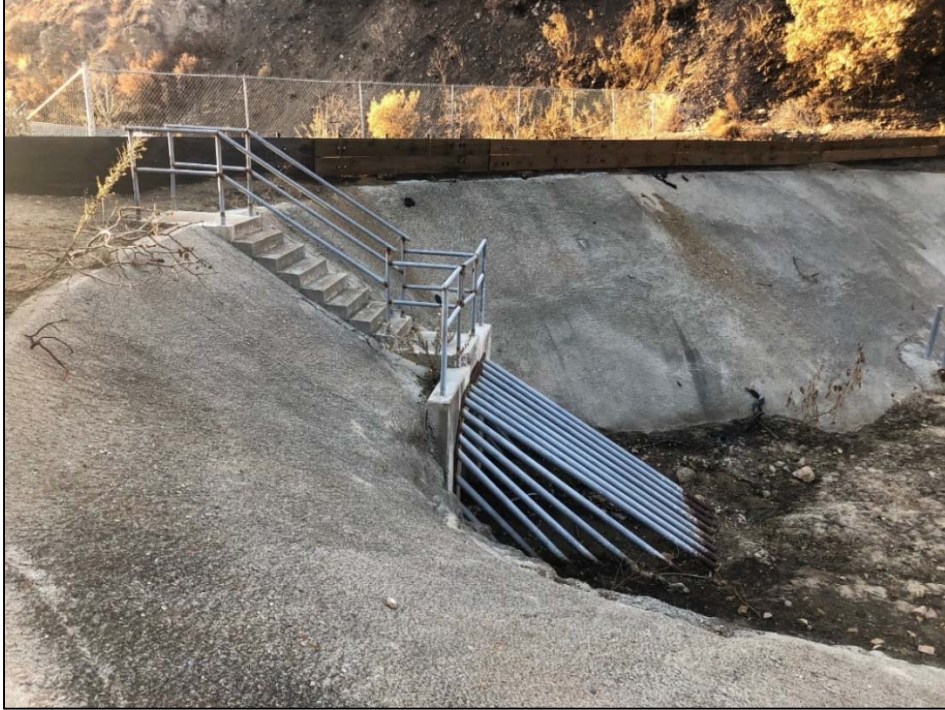
E-7. Upper Trancas Canyon debris basin, located in the Santa Monica Coastal Front region.

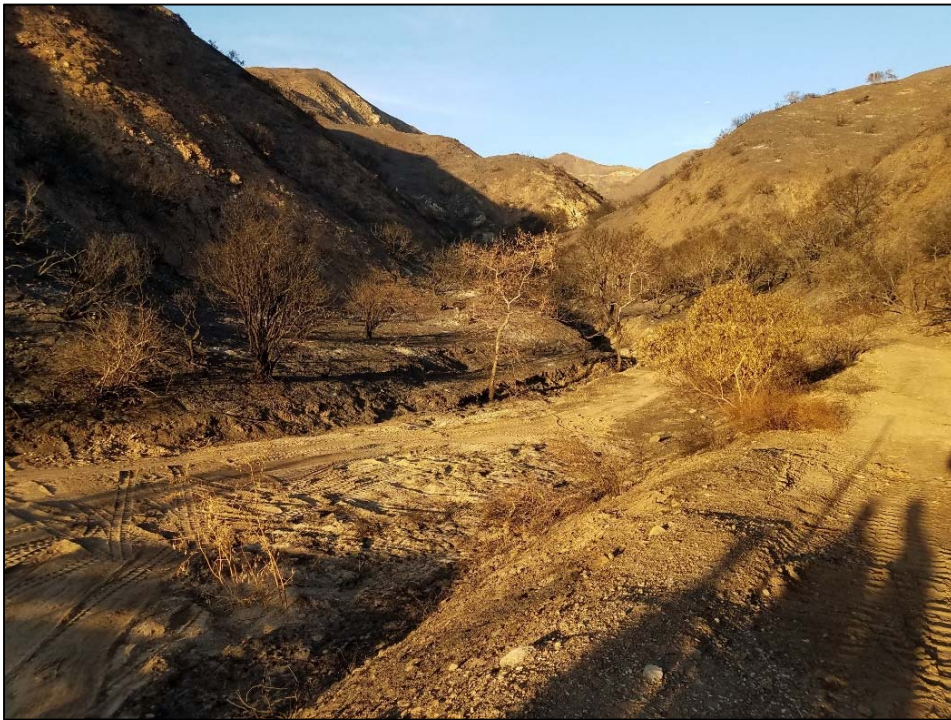
E-8. Upper Trancas Canyon above the debris basin.

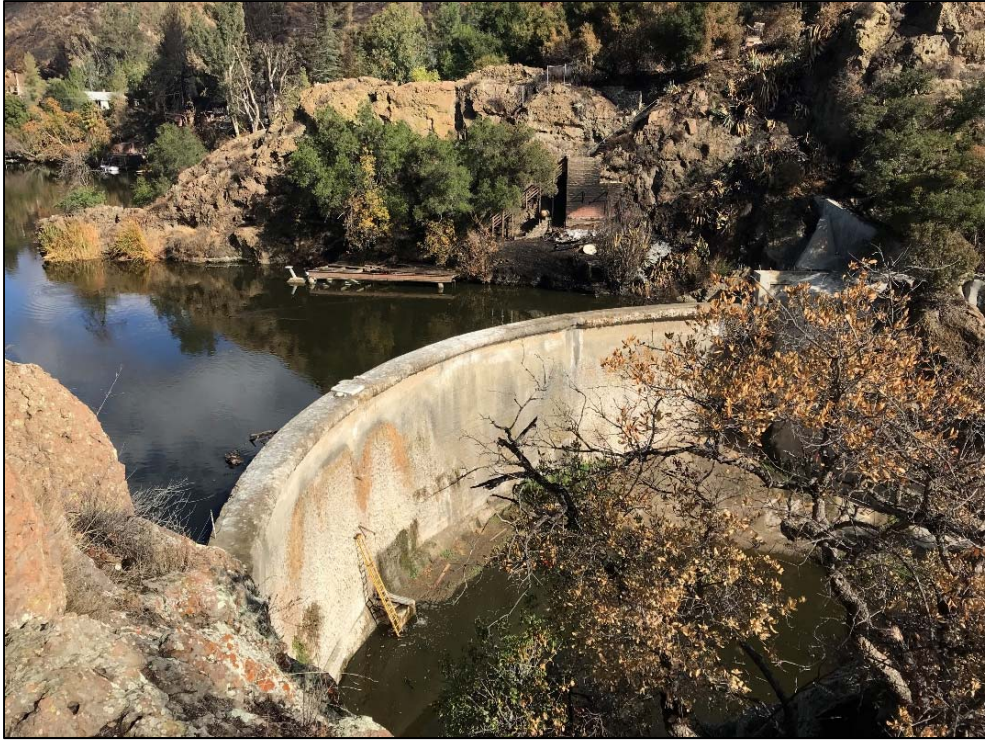
E-9. Malibou Lake dam.
