# WOOLSEY AND HILL FIRES

Watershed Emergency Response Team

Final Report

CA-VNC-091023 and CA-VNC-090993

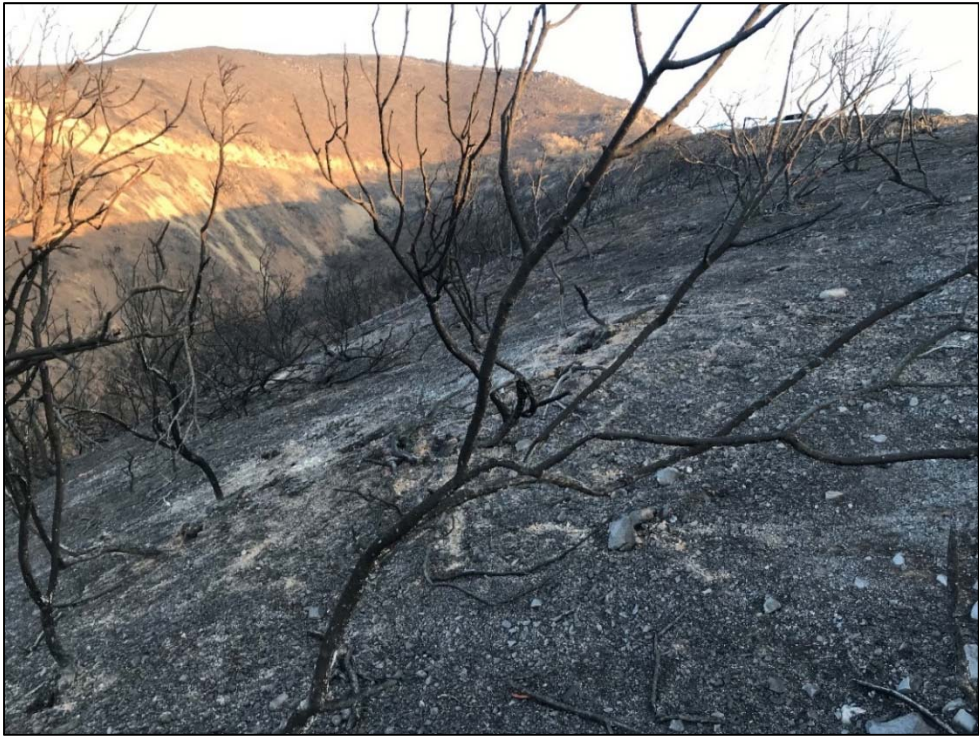
E-10. Hill Fire burned slope.

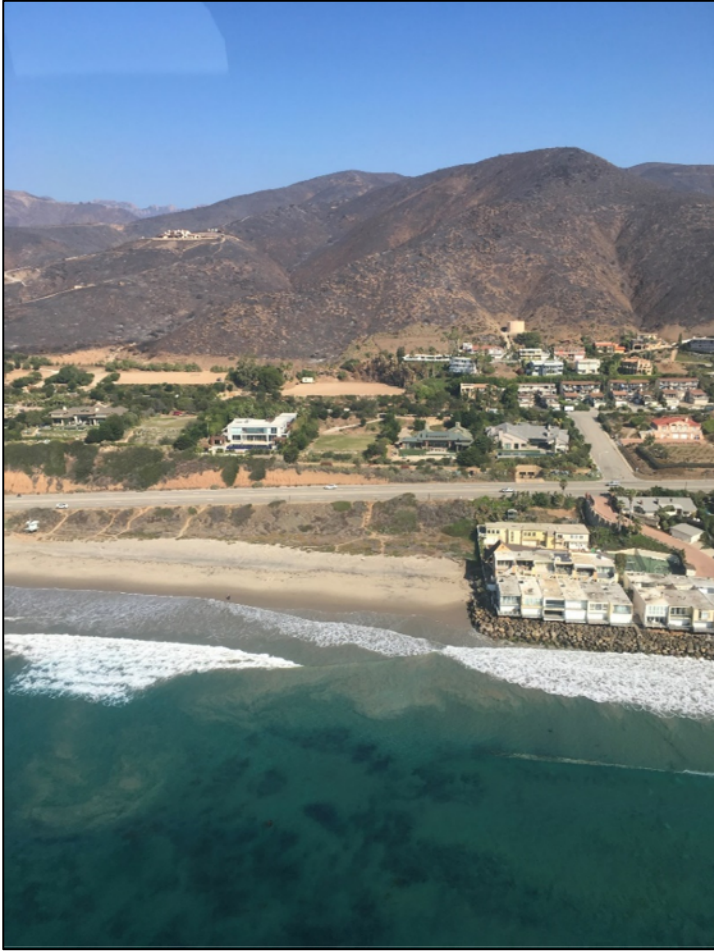
X-11. View of the Malibu Coast and the Woolsey Fire burn area from a helicopter flight on November 20, 2018.
